Does EMI Shielding Increase Vibration?

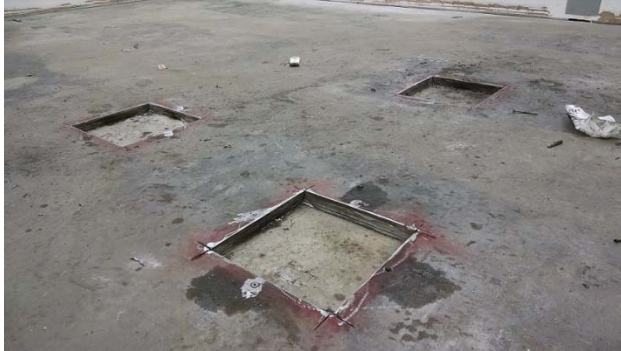
Example of shielding application that amplified vibrations. The shielding was comprised of aluminum, silicon steel, and low carbon steel. The shielding had to be cut to create pads for the equipment allowing the equipment to sit directly on the concrete slab. This resolved the vibration issue, but reduced the effectiveness of the shielding.

Summary of Results and Recommendations: As noted in this study, there have been examples where shielding did have an impact on vibration performance. In some of those cases, owners have cut holes in the shielding so that the instrument sits directly on the concrete, but they do so at the cost of a sacrifice in shielding effectiveness. However, extensive measurements at UC Irvine clearly demonstrate that if a shielding system is properly designed and installed, any impact it may have on the vibration performance of the room will be inconsequential and of little concern to performance of the microscope.

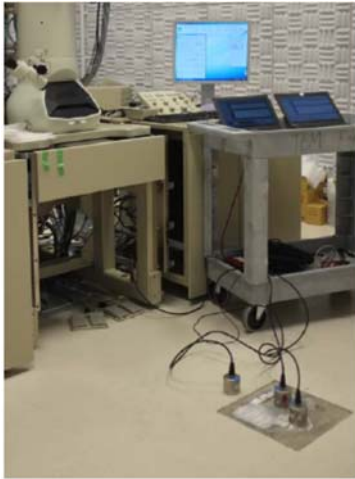
At the time of testing, the EM suites were largely complete, with equipment installed in the instrument rooms. Thus, an area near the center of each electron microscope room was prepared to expose an area of underlying concrete and an area of shielding. This allowed comparative measurements for three floor conditions:

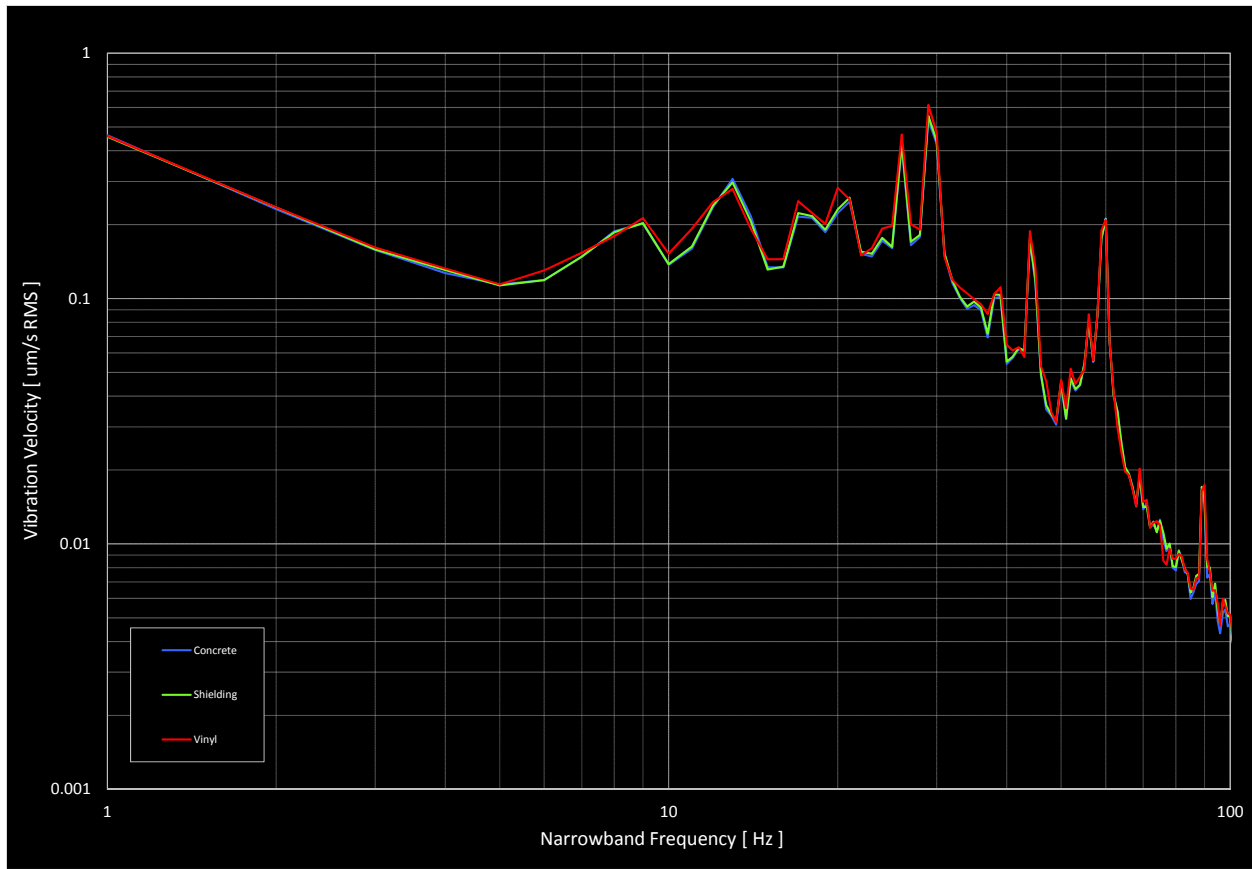
Figure 1 Spectral vibration measurements under ambient conditions. Simultaneous measurements of concrete, shielding, and vinyl flooring.

Under ambient conditions with activity restricted in the microscopy suite and control rooms, the maximum “shielding gain” – the amplification presumably introduced by the shielding – was 0.4 dB for higher frequencies and 0.2 dB for mid to lower frequencies, where the instruments tend to be more sensitive to vibrations. These figures are close to the experimental precision available in this test and are indicative of no practical effect. In fact, while the *maximum* shielding gain that was observed was less than 0.4dB across the spectrum, the *average* shielding gain (between different experiments) was close to zero.

The measurements demonstrate that the shielding does not contribute in a significant way to the vibration response of the floor system. Indeed, the vinyl flooring appears to amplify vibrations more than the shielding, but the complete floor system of concrete slab, shielding, and vinyl flooring still did not exhibit significant increases of vibrations from layer to layer.

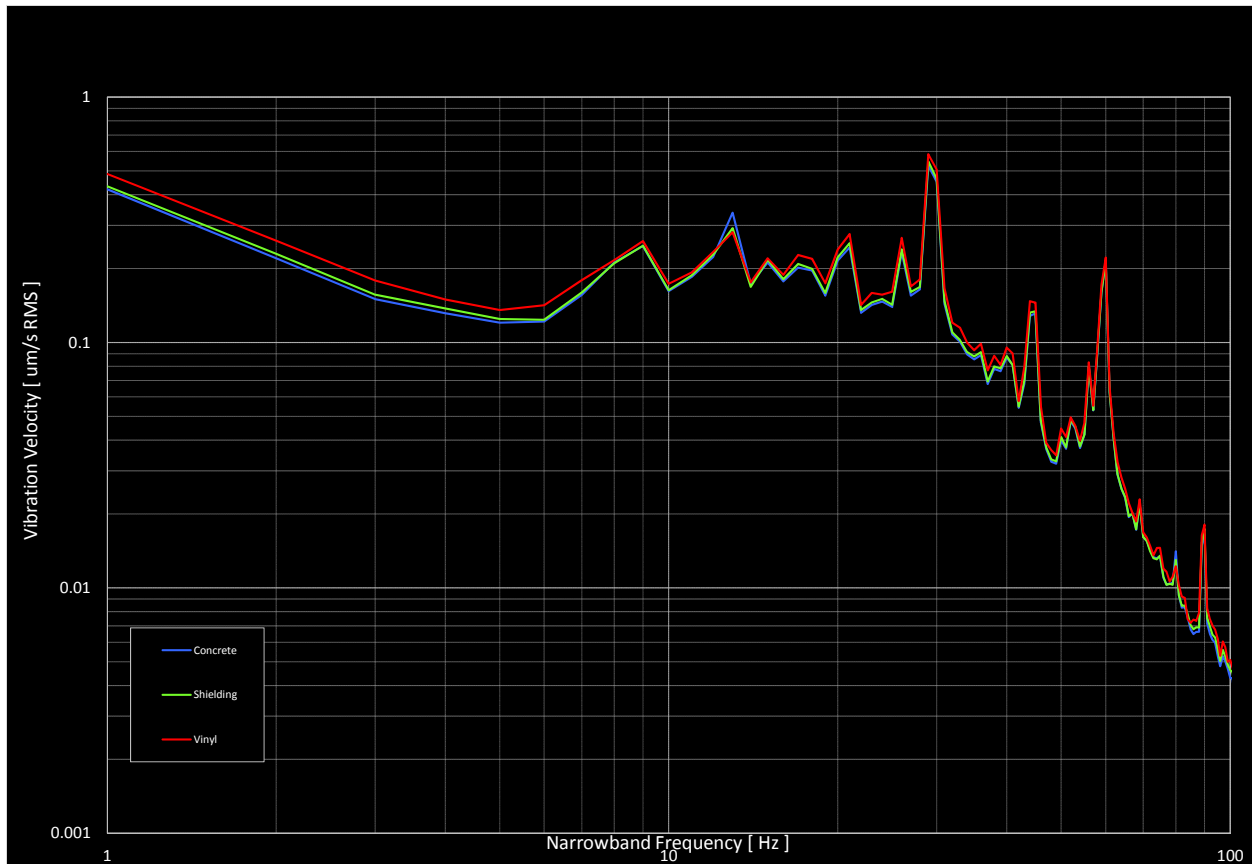
Figure 2 Spectral vibration measurements with activity in control room (rolling chairs, walking, and heel drops). Simultaneous measurements of concrete, shielding, and vinyl flooring.

A second set of measurements was conducted under purposeful forcing in the control room. Again, the observed shielding gain was 0.4 dB for higher frequencies, and 0.2 dB for mid to lower frequencies, while the average gain was very close to zero. This represented essentially identical gains to ambient conditions.

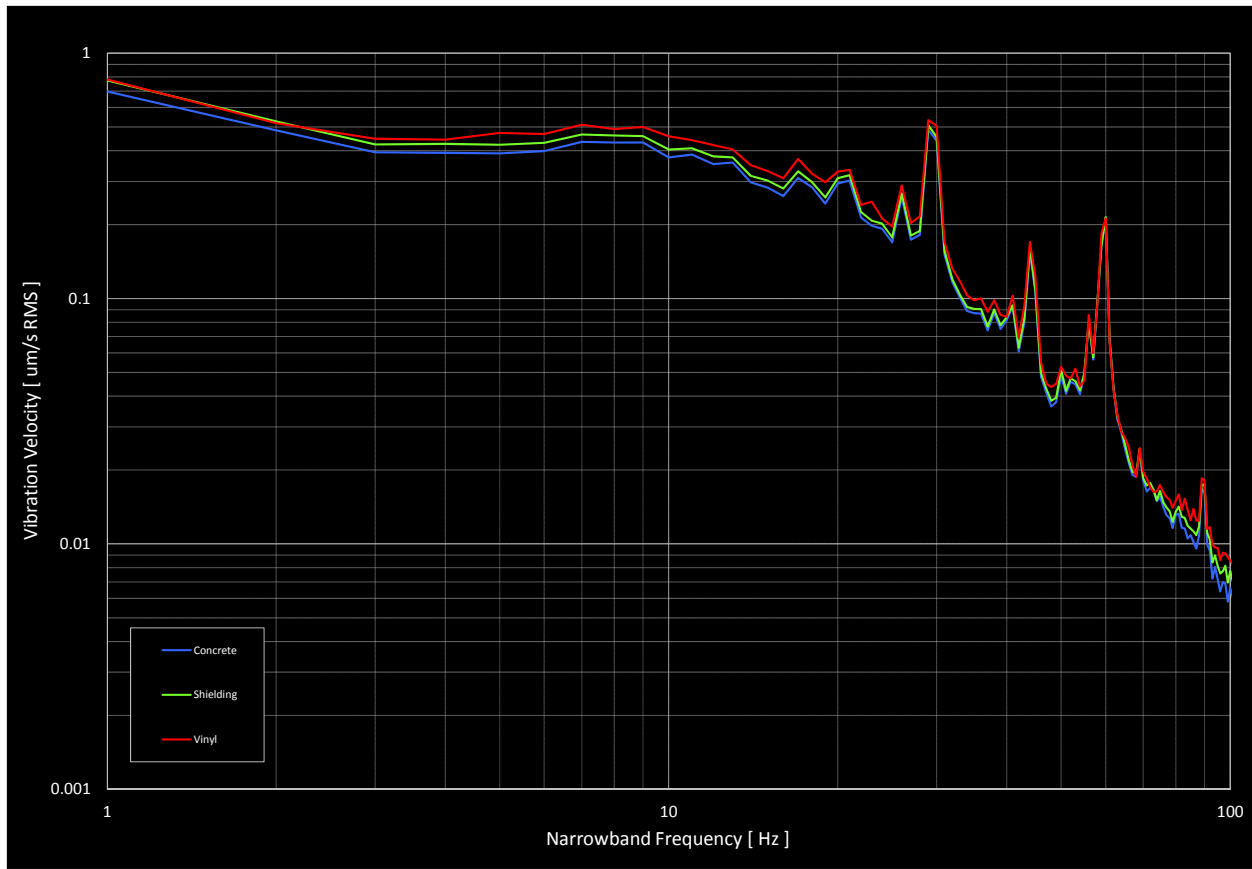
Figure 3 Spectral vibration measurements with activity in the instrument room (rolling chairs, walking, and heel drops). Simultaneous measurements of concrete, shielding, and vinyl flooring.

A final set of measurements was recorded under purposeful forcing inside the microscopy room. The maximum-shielding gain was 1.0 dB for higher frequencies and 0.7 dB for mid to lower frequencies, while the average gain was less than 0.4dB across the spectrum, similar to the ambient and forced control room results.
