DOES EMI SHIELDING INCREASE VIBRATION?

Field Management Services, Inc (FMS)

09.14.2017

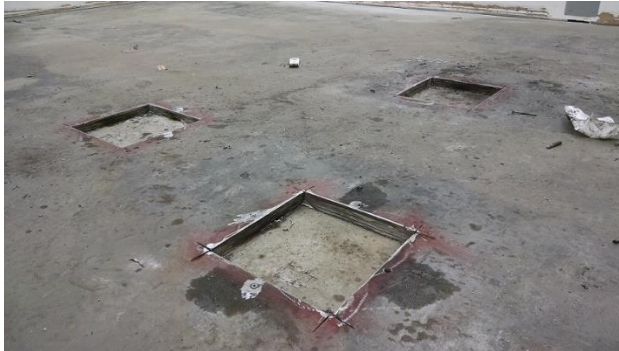
Example of shielding application that amplified vibrations. The shielding was comprised of aluminum, silicon steel, and low carbon steel. The shielding had to be cut to create pads for the equipment allowing the equipment to sit directly on the concrete slab. This resolved the vibration issue, but reduced the effectiveness of the shielding.

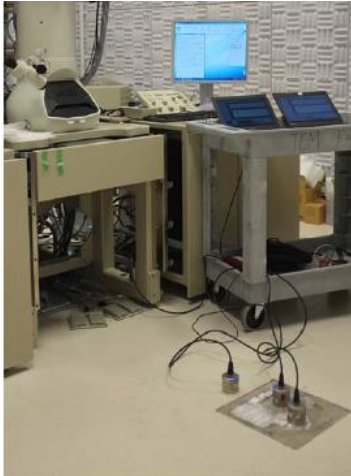
At the time of testing, the EM suites were largely complete, with equipment installed in the instrument rooms. Thus, an area near the center of each electron microscope room was prepared to expose an area of underlying concrete and an area of shielding. This allowed comparative measurements for three floor conditions:

- 1) subfloor/concrete (alone)
- 2) concrete plus shielding, and
- 3) concrete plus shielding plus final floor finish.

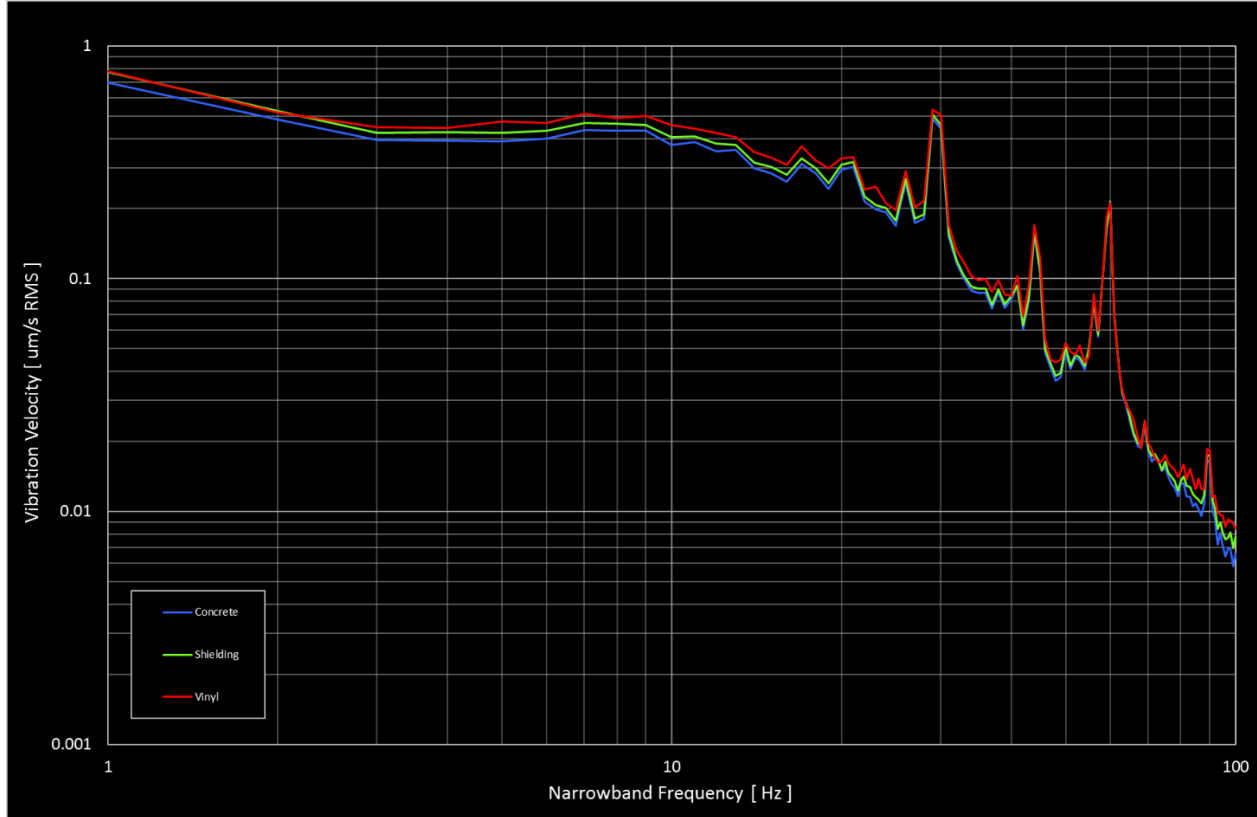
Figure 3 Spectral data from STEM-4 (JEOL JEM-2800), activities in Instrument Room (walking, chair roll, heeldrops). Data collected at locations noted in figure legend. The maximum-observed 1/3 octave band velocity = 0.88um/s RMS in the 25Hz band, meeting the VC-F criterion, meeting the VC-E criterion of 3.1um/s by a wide margin. Each spectrum is the average of 48 independent observations over the course of 240 seconds. Measurement Parameters: narrowband FFT ($df = 1\text{Hz}$; bandwidth = 1Hz). Each observation is a 5-frame (5-second) average, resulting in high sensitivity to transient events, which might be important to some forms of shielding influence. No windowing or overlap was used so that transient timing issues would be irrelevant in cases where multiple DAQs were deployed.

A final set of measurements was recorded under purposeful forcing inside the microscopy room. The maximum-shielding gain was 1.0 dB for higher frequencies and 0.7 dB for mid to lower frequencies, while the average gain was less than 0.4dB across the spectrum, similar to the ambient and forced control room results.

The measurements demonstrate that the shielding does not contribute in a significant way to the vibration response of the floor system. Indeed, the vinyl flooring appears to amplify vibrations more than the shielding, but the complete floor system of concrete slab, shielding, and vinyl flooring still did not exhibit significant increases of vibrations from layer to layer.
